CHILEAN COPPER MINE – CASE STUDY

In late 2013 **newterra** was contracted to design, build and rapidly deploy a modular and pre-manufactured 10 liter per second metals precipitation and solids removal system for a copper mine in Chile.

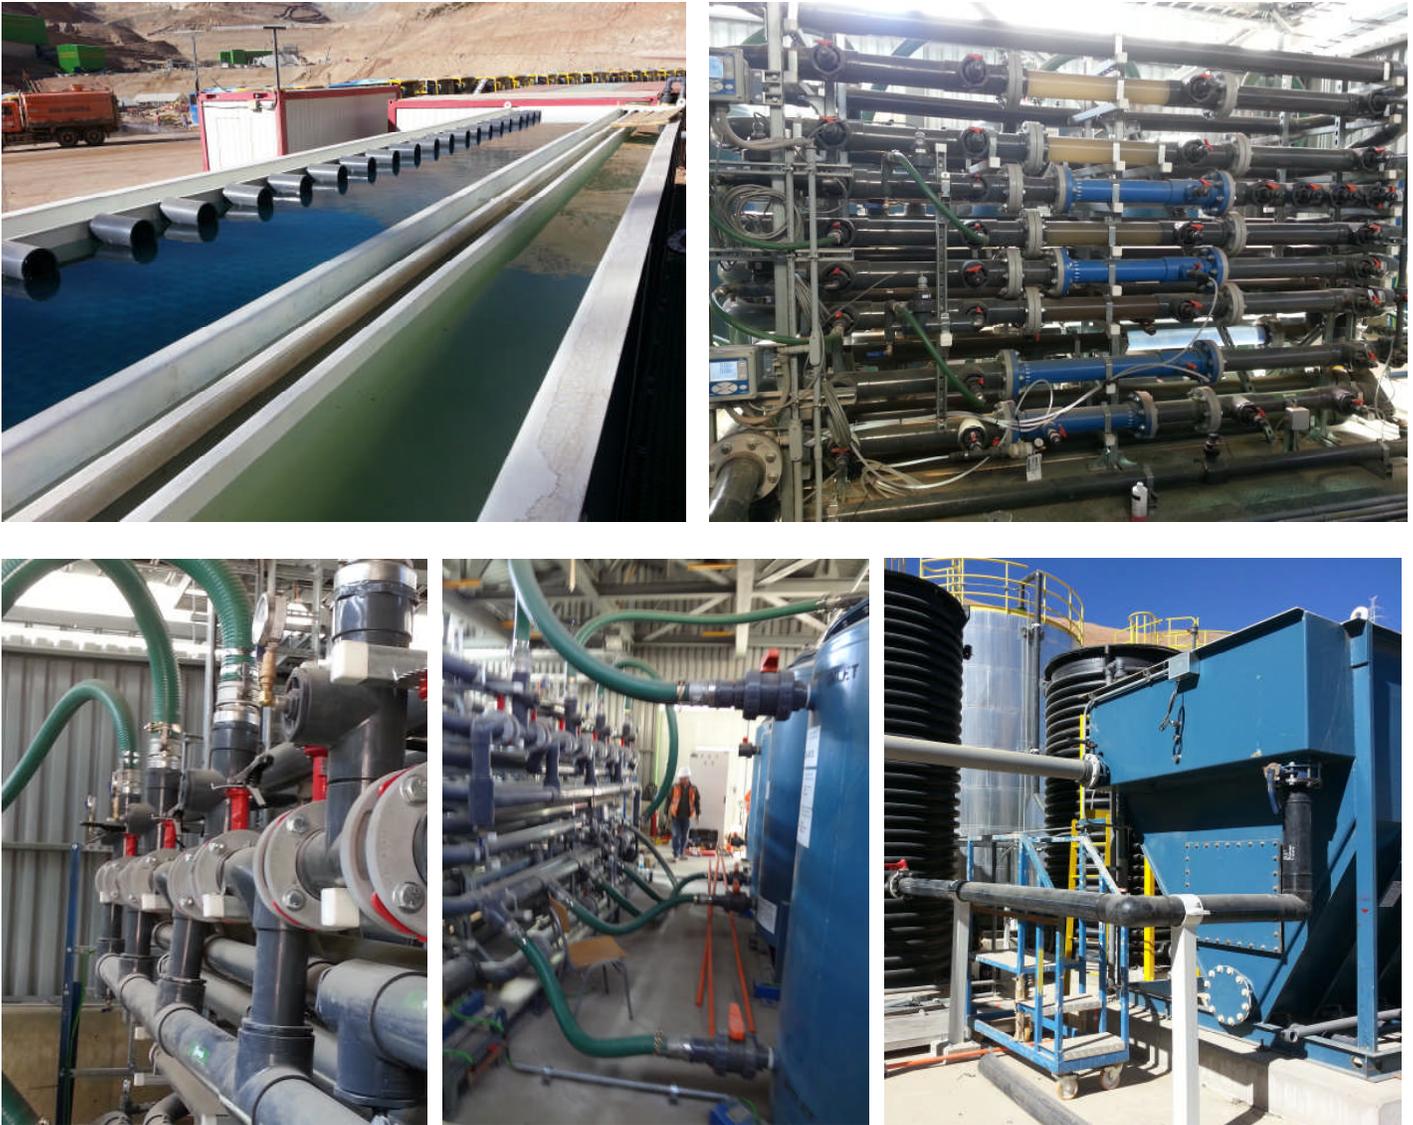
Figure 2. Site Photos

newterra met the schedule by designing a treatment solution utilizing pre-manufactured equipment packages that were already available in our North America based rental fleet. We rapidly modified and shipped the larger components by ocean freight which departed from our factory in early December. We following up with a second air freight shipment at the end of December which included the pre-wired and pre-tested control systems integrated onto the pump skids and pipe flocculator skid all modified to meet Chilean electrical requirements.

With the majority of the piping and electrical work completed and tested in our manufacturing plant, the installation commissioning and startup went smoothly allowing the customer to have a system ready for operation to meet the regulatory requirements.

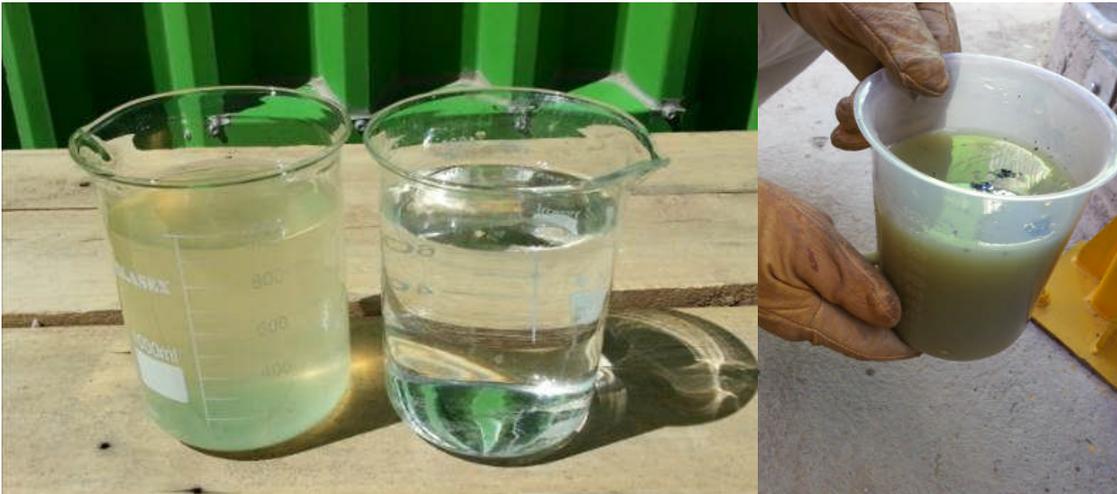
Figure 3. Water Quality Photographs

Inlet (left sample), Effluent (middle sample), Sludge in bottom of clarifier (right sample)
