GROUNDWATER TREATMENT SYSTEM – CASE STUDY

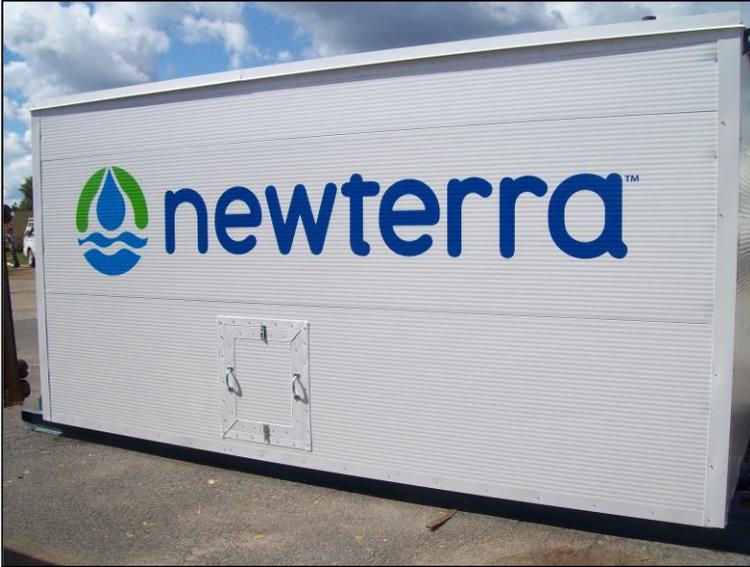
Figure 1. Treatment Process Implemented

Raw water from the wells is fed to an inlet tank. This water is then fed to the **newterra** longbox clarifier, a gravity clarifier that uses settling media to improve performance. A typical gravity clarifier easily allows larger, heavier particles to separate from the flow and settle to the bottom. By installing tube settling media in our gravity clarifier, **newterra** is able to dramatically increase the available settling area and reduce the settling distance, which allows the **newterra** longbox clarifier to separate much finer solids. The raw water at this remediation site has a measured total suspended solids (TSS) level of 66 ppm.

The clarified water is gravity fed to an outlet tank, and then pumped through three **newterra** multimedia filters, operating in parallel to further reduce suspended solids. When the multimedia filters become loaded with solids, they are backwashed to the inlet of the clarifier. Currently, the multimedia filters are being backwashed once per week, although the measured pressure drop across the vessels is quite low and backwashing frequency could be further reduced.

For final solids removal the water is fed through parallel bag filters. Suspended solids downstream of the bag filters are being reduced to less than 3 ppm. The clarifier and multimedia filters have been so effective at removing suspended solids that the bag filters are only being changed once per month. This marks an incredible improvement over the operational requirements of the original system.

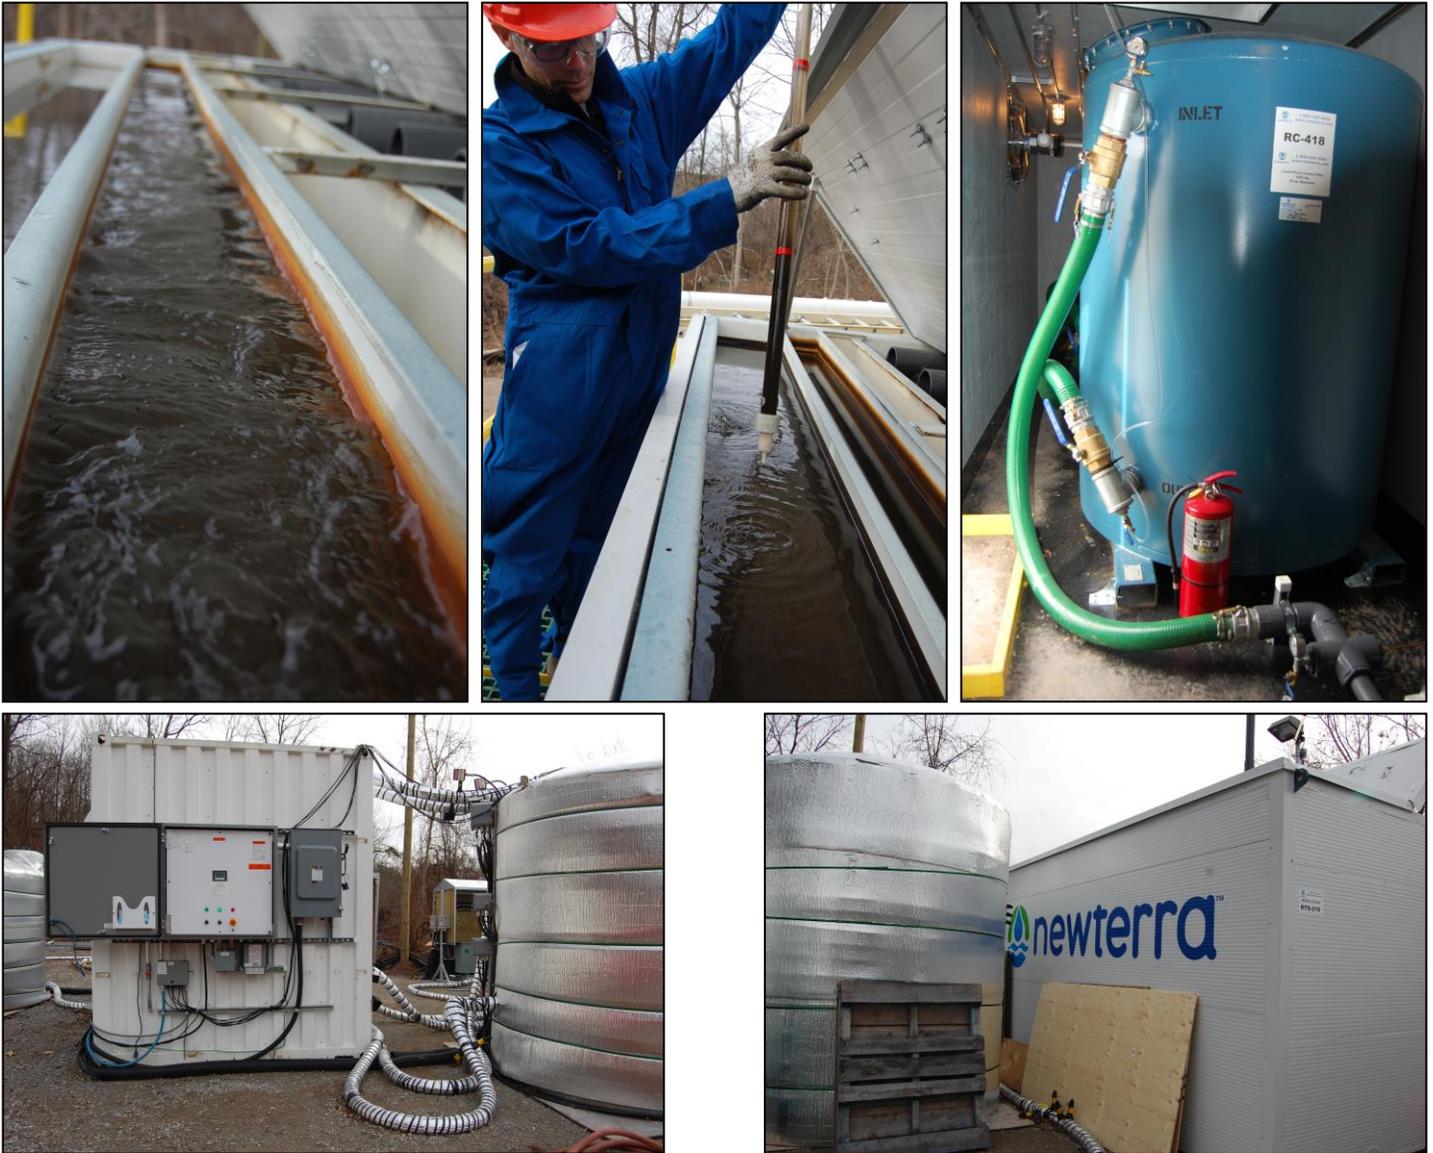
Figure 2. Site Photos

This site presented challenges because of ambient temperature during the winter months. All equipment needed to be insulated and heated to prevent equipment damage and system failure due to freezing. The multimedia vessels, bag filters, and carbon vessels were housed in converted shipping containers, with insulation and heat. Due to the height of the multimedia and carbon vessels, and the need for media change out, the buildings were equipped with roof access hatches. The clarifier presented a more difficult challenge as it is too large to be operated inside any type of building that could have been shipped to site. Consequently, **newterra** designed the clarifier as a standalone unit, with its own insulated shell and heaters. Even with an insulated shell, the clarifier can still be operated as normal; inspections, water sampling, sludge removal, etc. can all be done without disassembling or shutting down the treatment process.

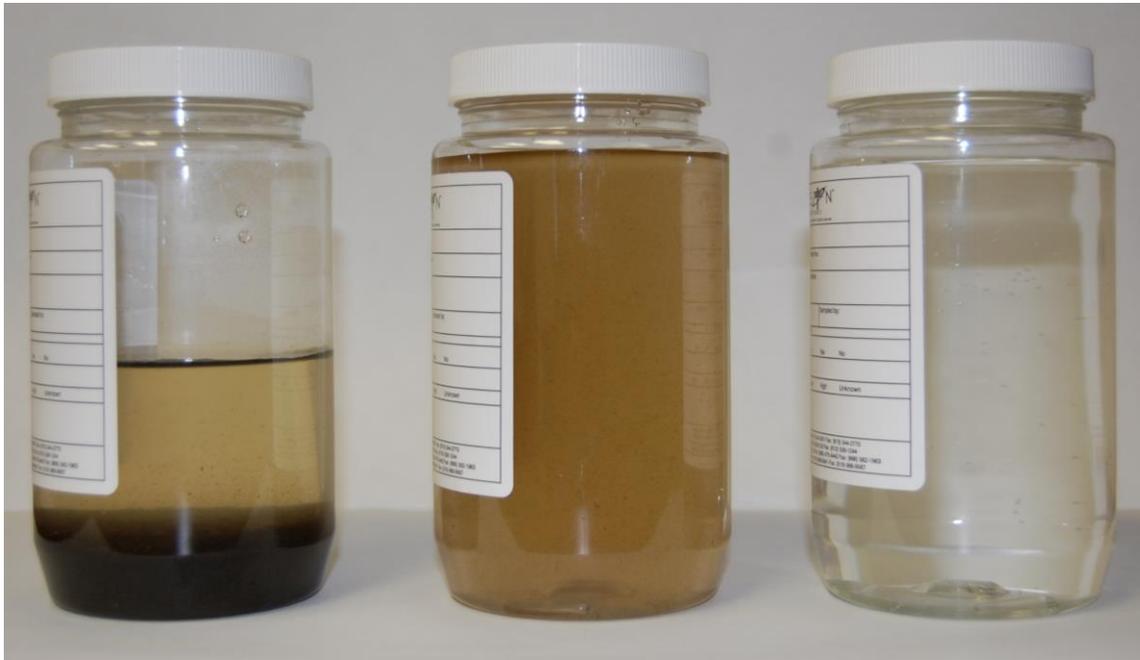
Figure 3. Water Quality Photographs

Left: sludge from bottom of clarifier; Middle: system inlet water; Right: system discharge water

Parameter	System inlet	System discharge
Total Suspended Solids mg/L	66 mg/L	<3 mg/L
